## MLEC Failure Analysis – The Final Chapter

John Mayer

Hawthorne Auto Clinic

3-5-2014

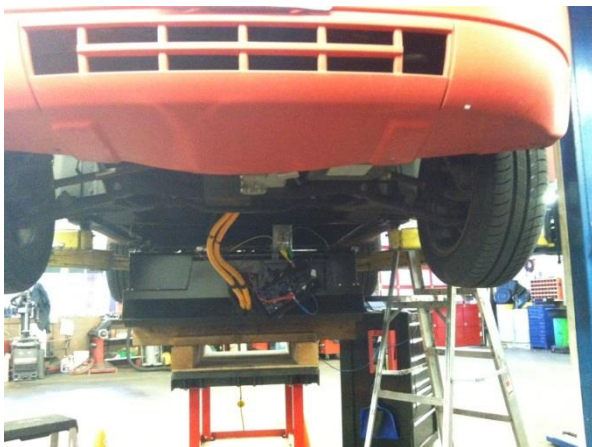
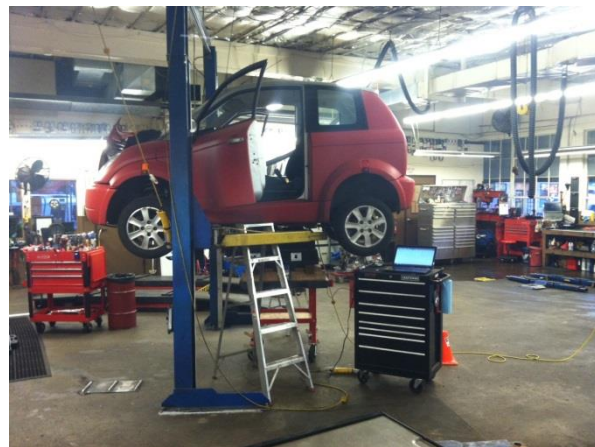
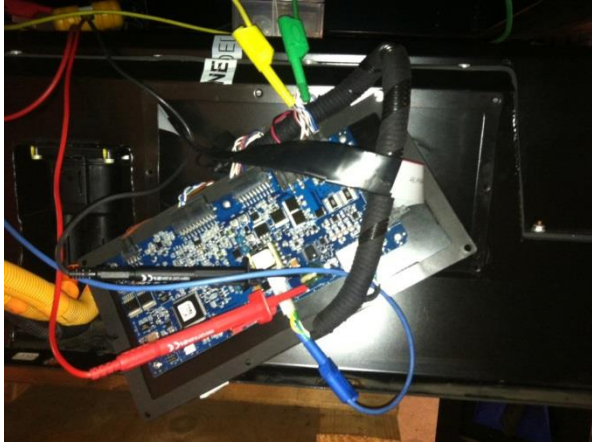
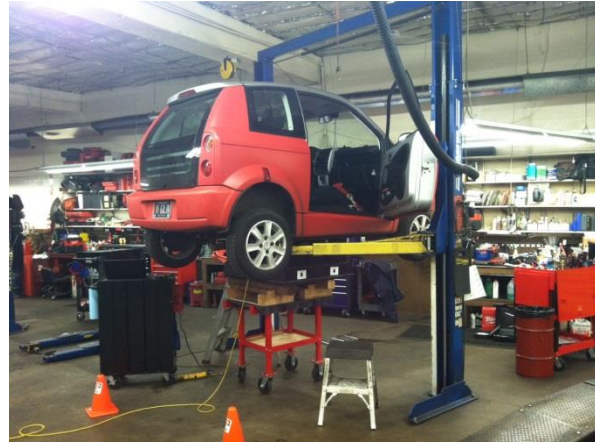
The photos below illustrate the test set-up that was reconstructed several times over the course of just over a year in trying to document an MLEC failure.

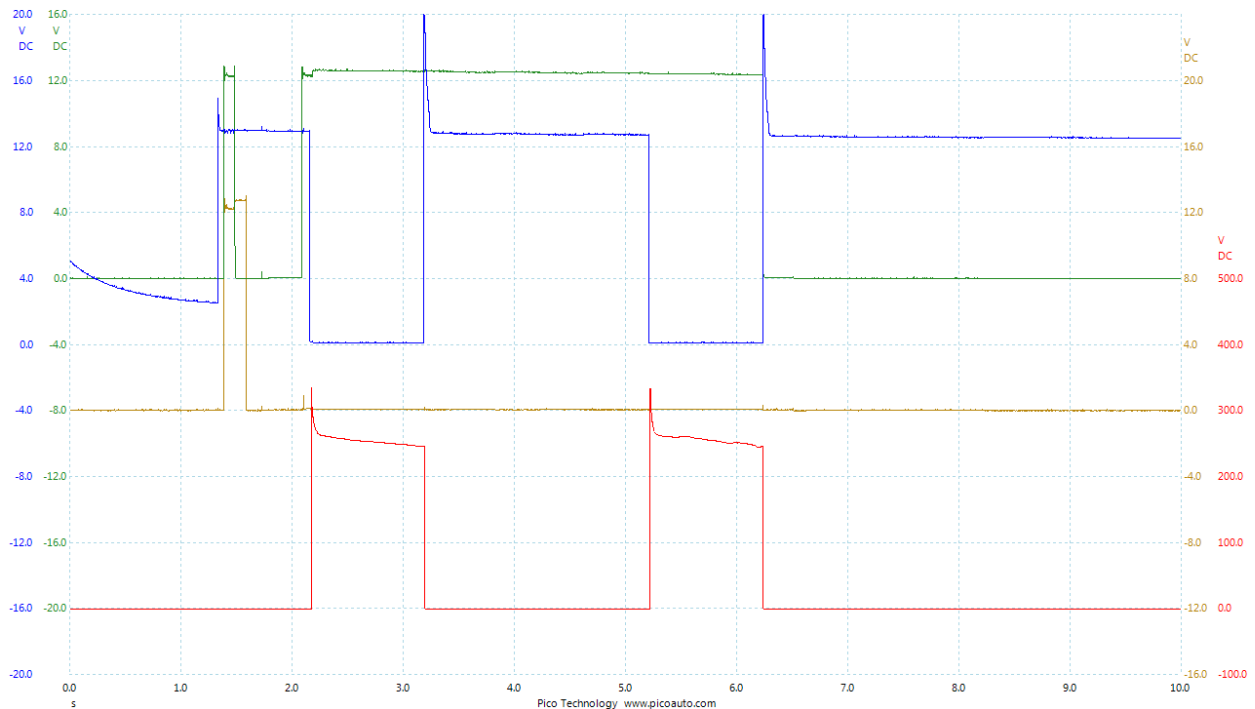
The trace starts just after the contactors have opened, about 2 seconds after the key has been turned off with the cabin heater still on. Key on occurs at about 1.3 seconds.

The blue trace is the precharge contactor driver signal. When this trace is 0V, the precharge contactor is energized (closed).

The green trace is the driver for Main Contactor 1. When this trace is 12V, the contactor is energized (closed).

The yellow trace is the driver for Main Contactor 2. When this trace is 12V, the contactor is energized (closed).

The red trace is the voltage across the precharge resistor, measured directly at the precharge resistor through a 100:1 differential scope probe.

Note that the blue, green and yellow traces are all shown at a scale of 4V per division, but the 0V levels are offset from each other to simply avoid overlapping of signals. The red trace scale is 100V per division.

At approximately 1.3 seconds the key is turned on, and voltage is applied to the precharge contactor through the emergency power off (EPO) circuit (but this does not energize the precharge contactor—it is only energized when the driver signal is pulled to ground). Main Contactors 1 and 2 are briefly energized to test their operation just hundredths of a second after key on. At approximately 2.1 seconds, Main Contactor 1 is energized and shortly thereafter the precharge contactor is energized. Normally we would see the voltage across the precharge resistor spike to battery voltage and then decay to near zero within 0.4 seconds. But in this case voltage across the precharge resistor remains greater than about 250V for an entire 1 second. The precharge contactor de-energizes (opens) for 2 seconds, and then closes again. The voltage across the precharge resistor is about the same as it was in the previous precharge attempt.

Assuming that battery voltage was around 350V for this snapshot and the average voltage across the precharge resistor was about 250V, this circuit behavior is what would be predicted with about a 20 Ohm load across the PCU's internal capacitors. The energy dissipated as heat in the precharge resistor during each of the two precharge attempts was over 1300 Joules, so that by the end of this snapshot 2600 Joules, well over three times its 700 Joule rating, had gone into the resistor. The result is dramatic, but does not cause the resistor to fail immediately. The still photos below, taken from video concurrent with the oscilloscope capture above, show a large flame and smoke pouring from the resistor after the second precharge attempt.

The best solution to the problem would still be prevention of the precharge resistor from being damaged regardless of any conditions external to the battery. I recommend that we pursue a solution by modifying the BMS software to prevent precharge resistor overheating. This discovery of the MLEC failure mechanism comes only a few days after I composed and submitted a proposal titled, “Think City Precharge Circuit Behavior Modification,” and I still stand by that recommendation.

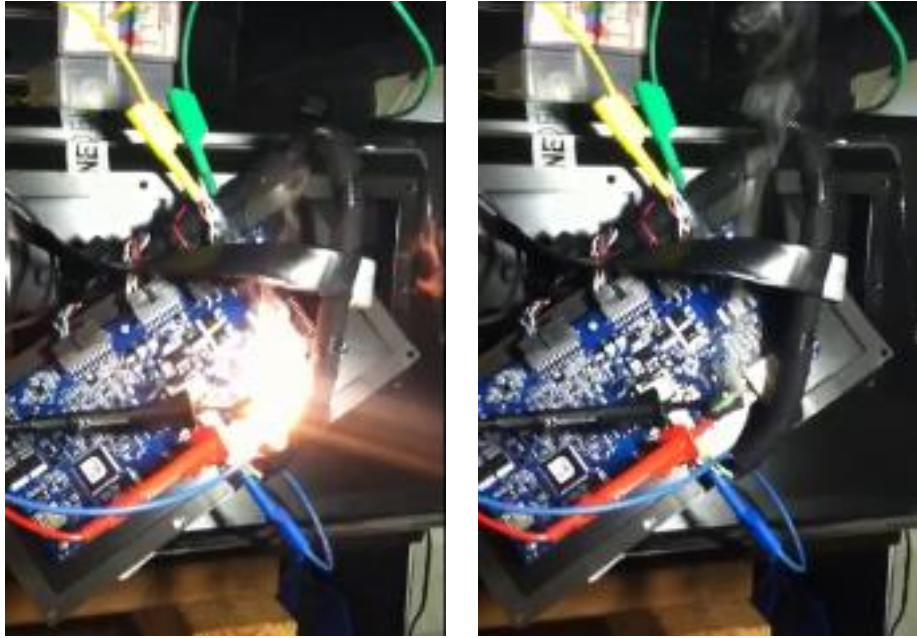
But after the resistor had a chance to cool off it continued to work properly to start up the car, with the exception that it emitted a bright flash of light each time it was energized. There is no telling how long an overheated precharge resistor can go on working properly—or even intermittently—before it finally gives out due to mechanical vibrations or deterioration from repeatedly being energized in a degraded state.

Additionally, we should officially communicate this important finding to Think owners as soon as possible and advise them how to avoid damage to their cars. Think owners have already been advised to turn off all 12V loads as a precaution, but I believe that relaying the specific message to turn the blower off before turning off the car and before turning the key on will be heeded much more strictly if the recipients of the message understand how ignoring that specific action can immobilize their car.
